Energy audit for Energy Efficiency in Buildings

Keywords: Energy Audit, Dorm, Energy Class, ENSI Software

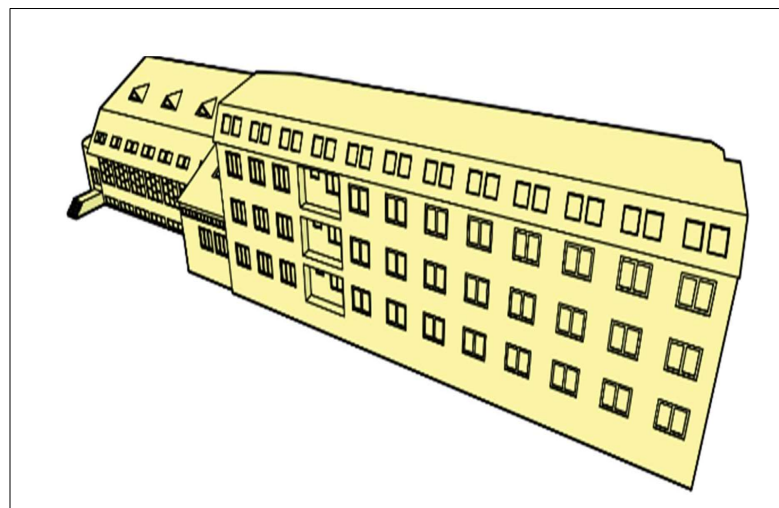
Figure 2. Appearance of the building from the south-west

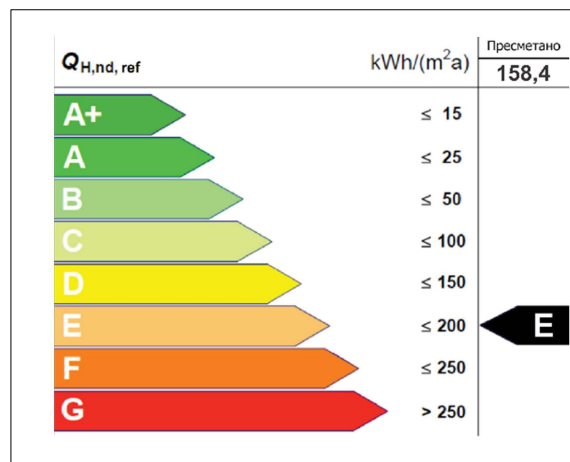
Figure 3. Calculated energy class of the building

The results from the calculations categorized the building of the High school dorm "Mirka Ginova" – Bitola as class "E" building. Calculated value of energy consumption is 158,4 kWh/(m²a).

According to the National legislative, [2], all buildings undergoing 'substantial reconstruction' must reach at least "D" energy class.

- Thermal insulation of all external walls in order to reach maximum allowed U-value of 0,35 W/m²K;
- Partial replacement of windows and carpentry in order to reach maximum allowed U-value of 1,7 W/m²K;
- Installation of additional thermal insulation for the roof in order to reach maximum allowed U-value of 0,25 W/m²K;
- Replacement of one of the hot water boilers running on light oil fuel with high efficiency hot water boiler running on wood pellets.
- Replacement of light bulbs and fluorescent lighting tubes with LED lights;
- Implementation of these measures would 'raise' building's energy class to "C".

Return on Investment (ROI) period for implementation of these measures was also calculated and it ranges from 2 years (lights replacement) up to 5, 5 years (replacement of windows and corresponding carpentry)
